Boston Harbor South Watersheds 2004 Assessment Report

June 30, 2004

**Prepared for:
Massachusetts Executive Office of Environmental Affairs**

**Prepared by:
Neponset River Watershed Association
University of Massachusetts, Urban Harbors Institute
Boston Harbor Association
Fore River Watershed Association
Weir River Watershed Association**

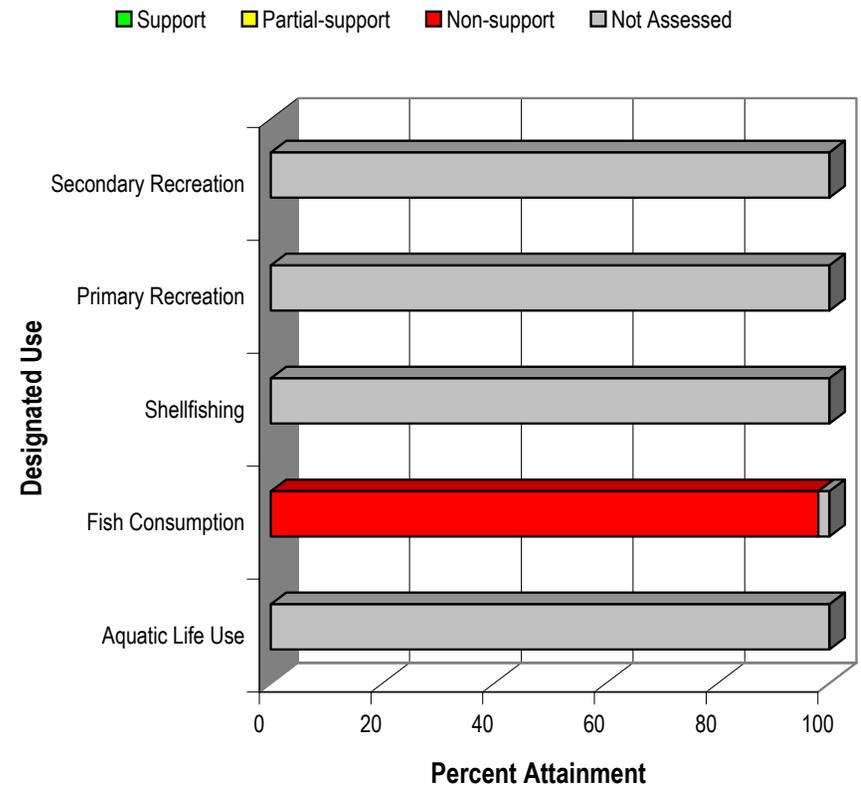
Figure 6:

Neponset Watershed: 1999 DEP Assessment of Estuary

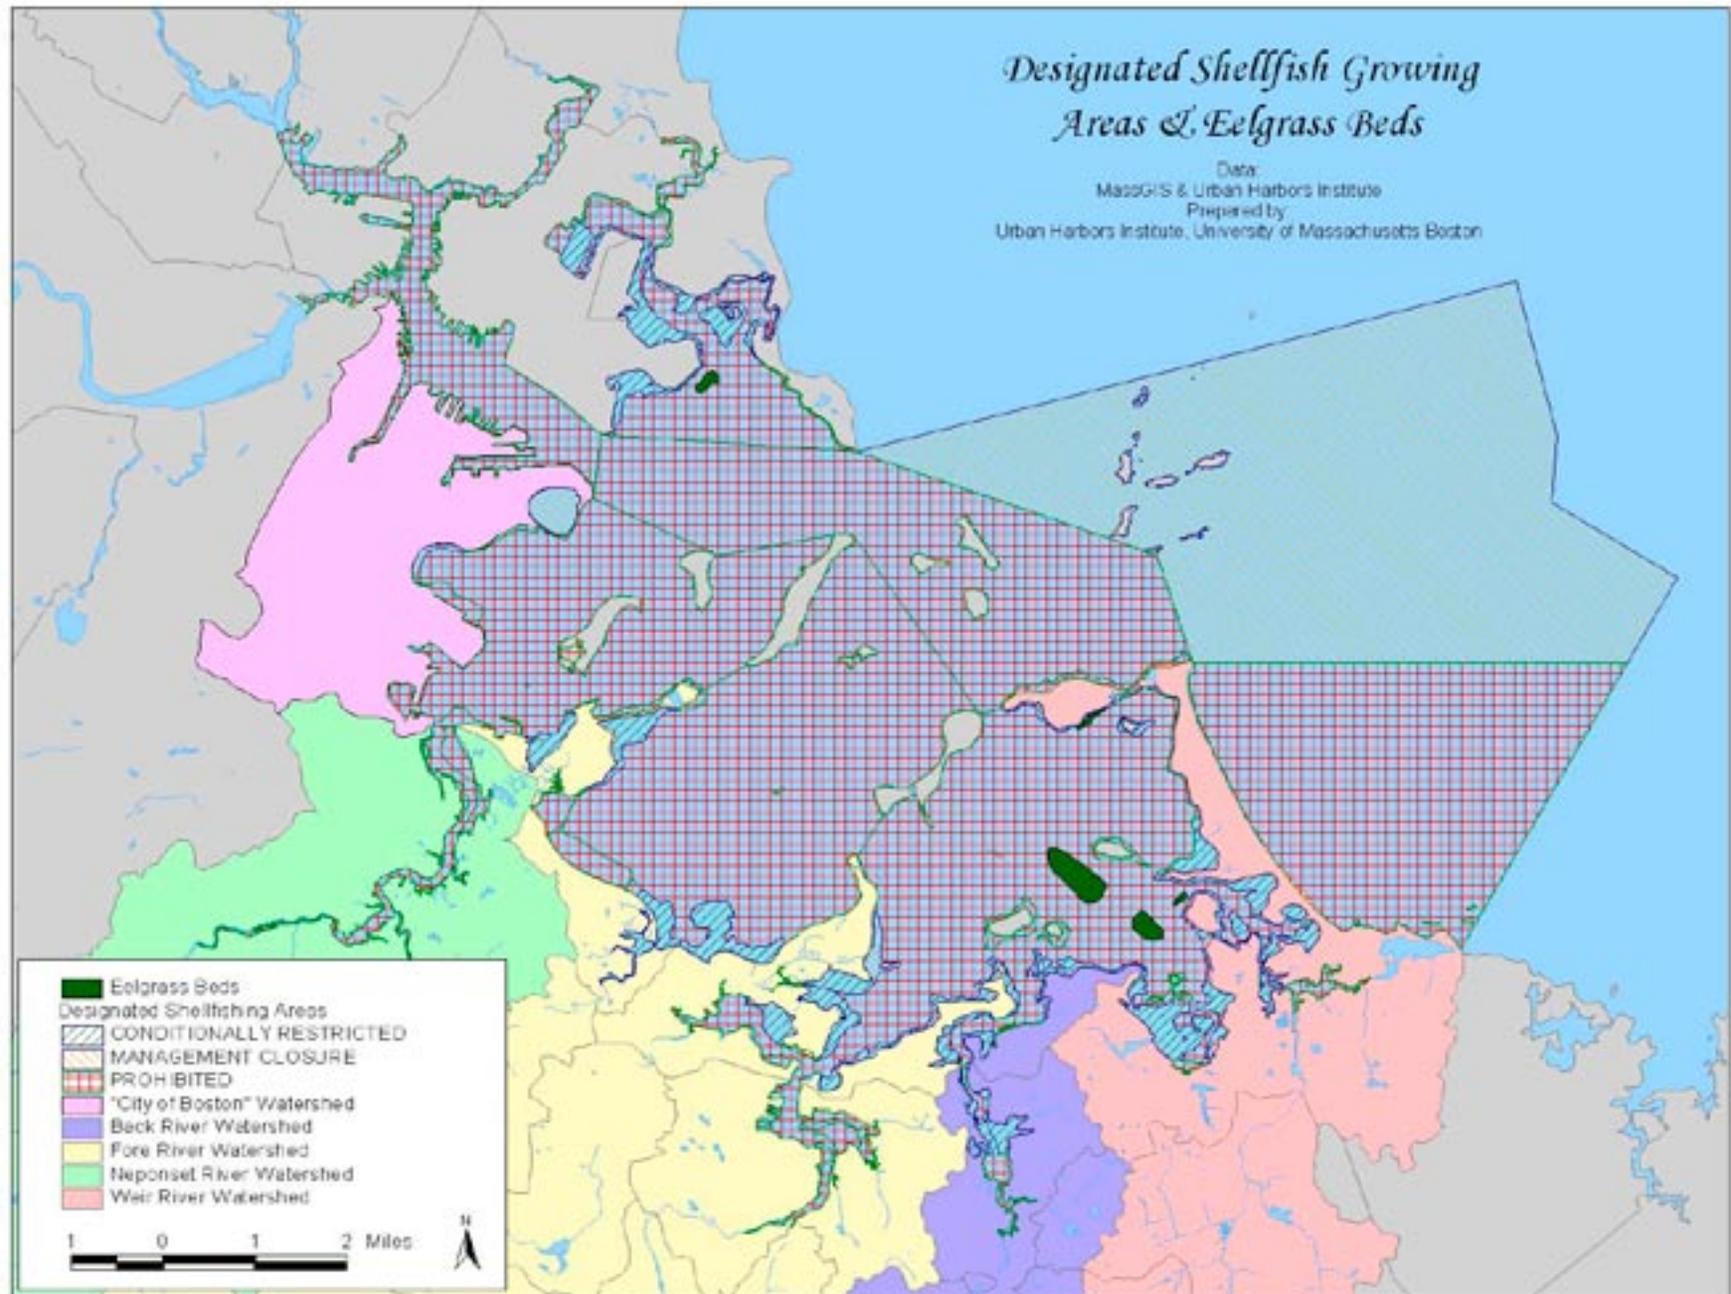
Figure 10: Shellfish Areas and Eelgrass Beds

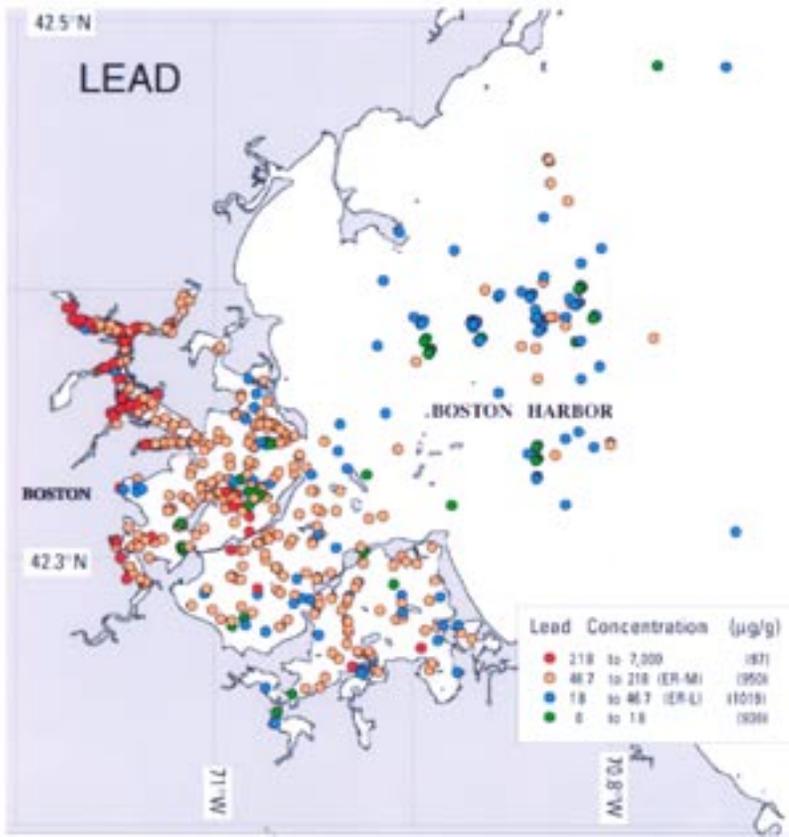
Figure 16: Lead Concentrations in Sediments of Boston Harbor (USGS)

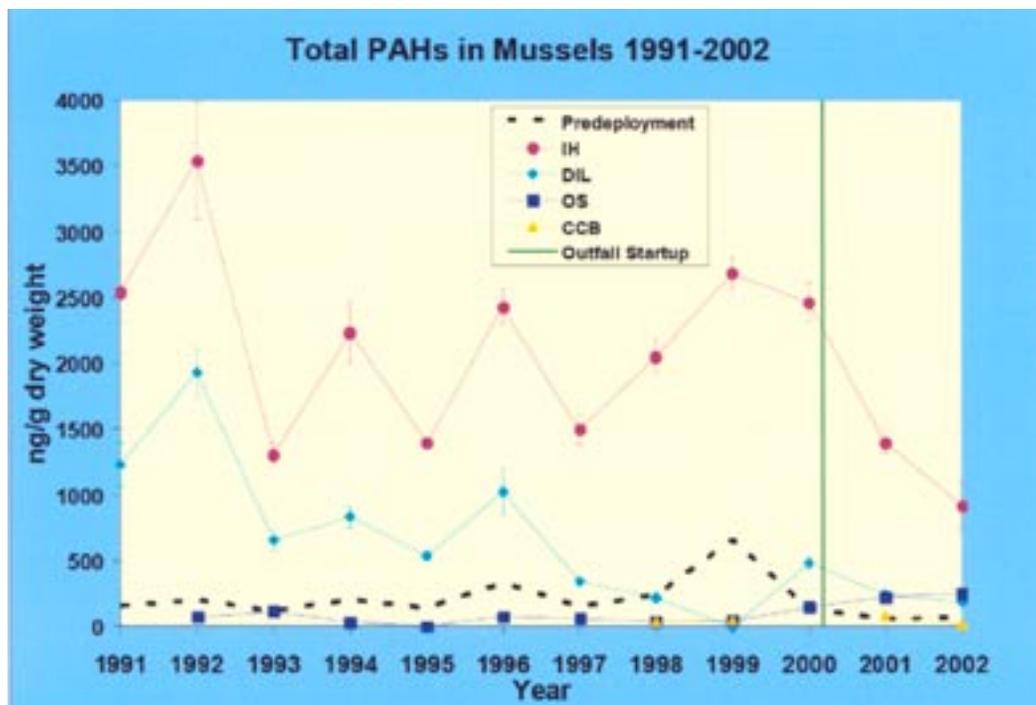
Figure 17: PAHs in Boston Harbor Mussels (MWRA)

As part of the MWRA’s ongoing fish and shellfish monitoring program, caged blue mussels from Rockport were deployed in several locations around Boston Harbor to evaluate bioaccumulation potential. The mussels were suspended in cages for 60 days at sites near the New England Aquarium, the former Deer Island outfalls, the offshore outfall site, and Cape Cod Bay. Once retrieved, the mussels were analyzed for toxic contamination. As shown in Figure 7, results indicated that PAHs found in mussels left in the Inner Harbor (IH) were higher than other locations such as Deer Island Light (DIL), the Outfall Site (OS) and Cape Cod Bay (CCB).

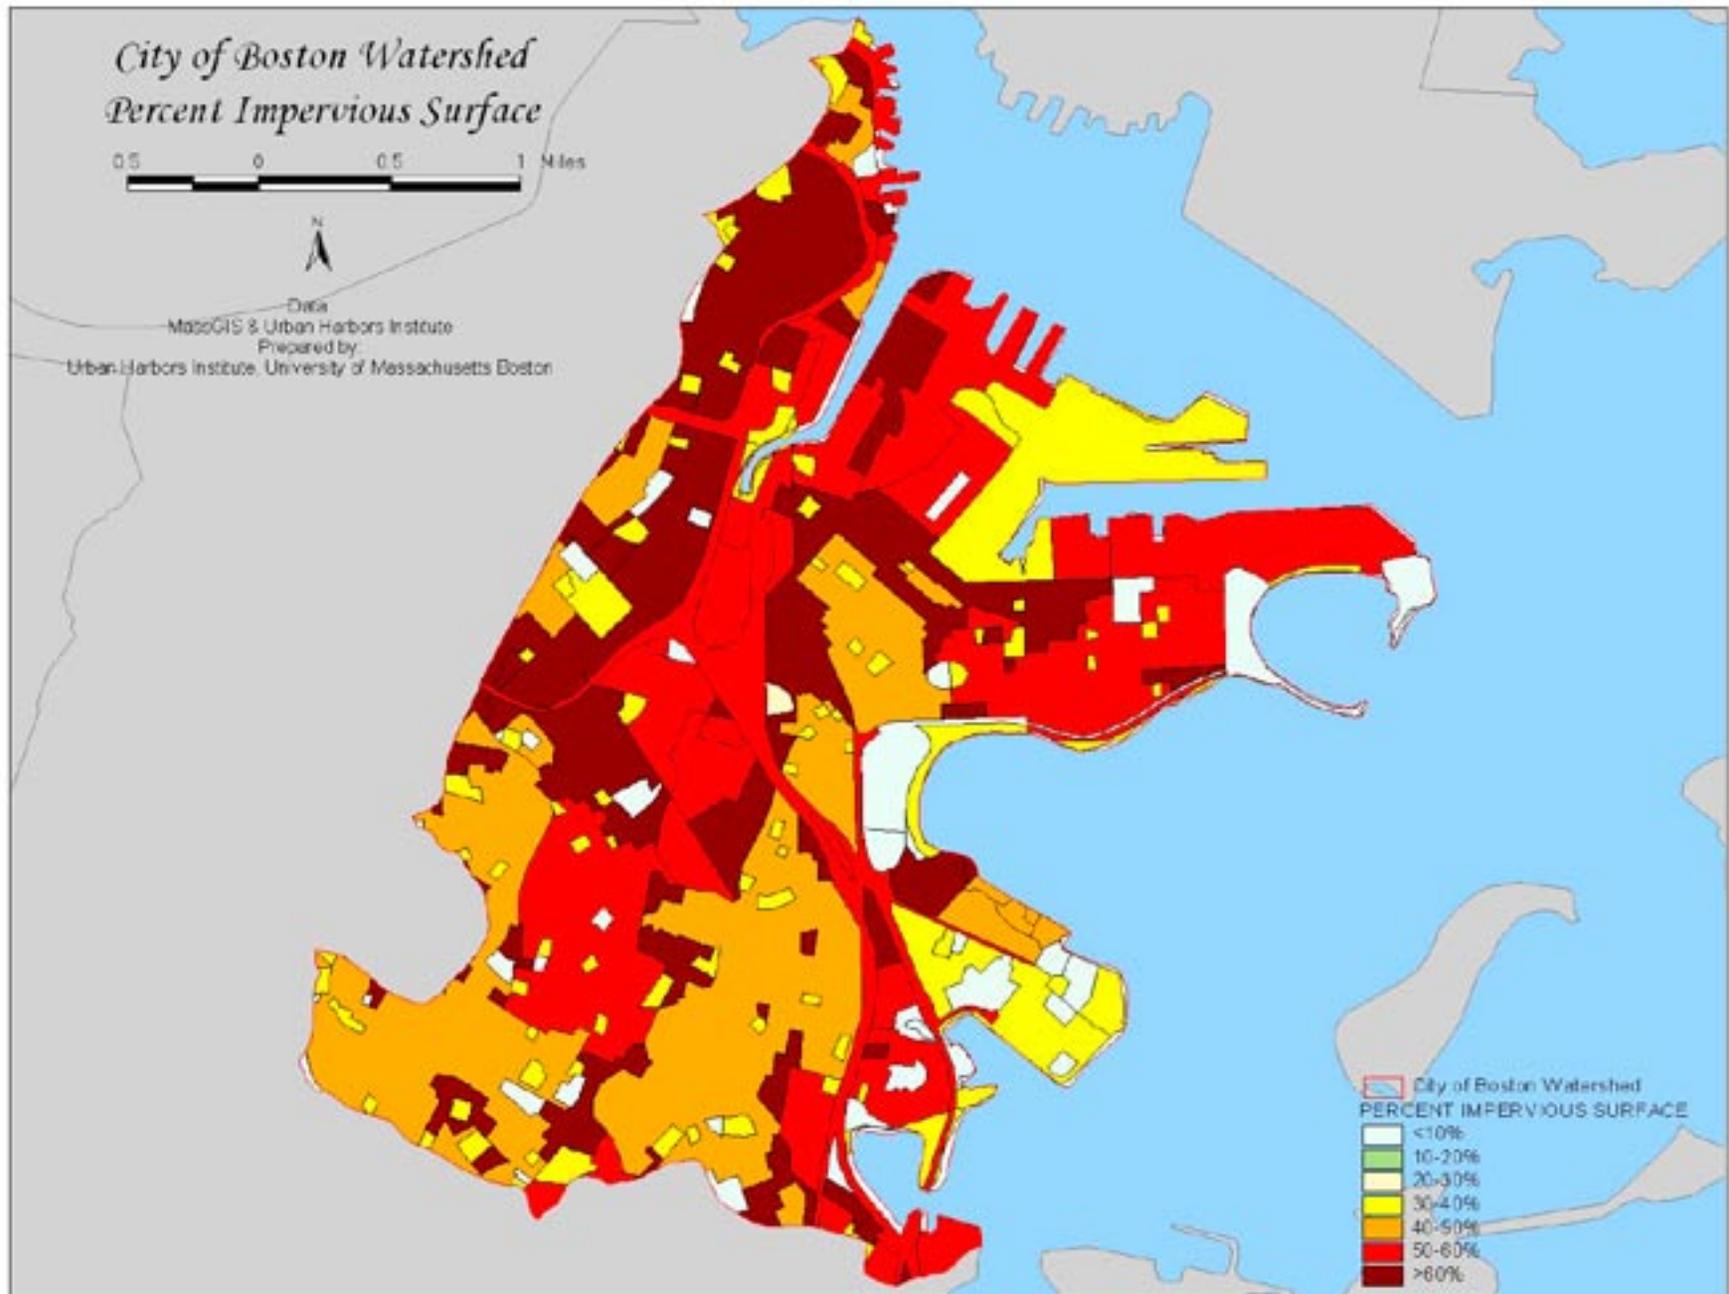
Figure 19: Boston Watershed Impervious Surface:

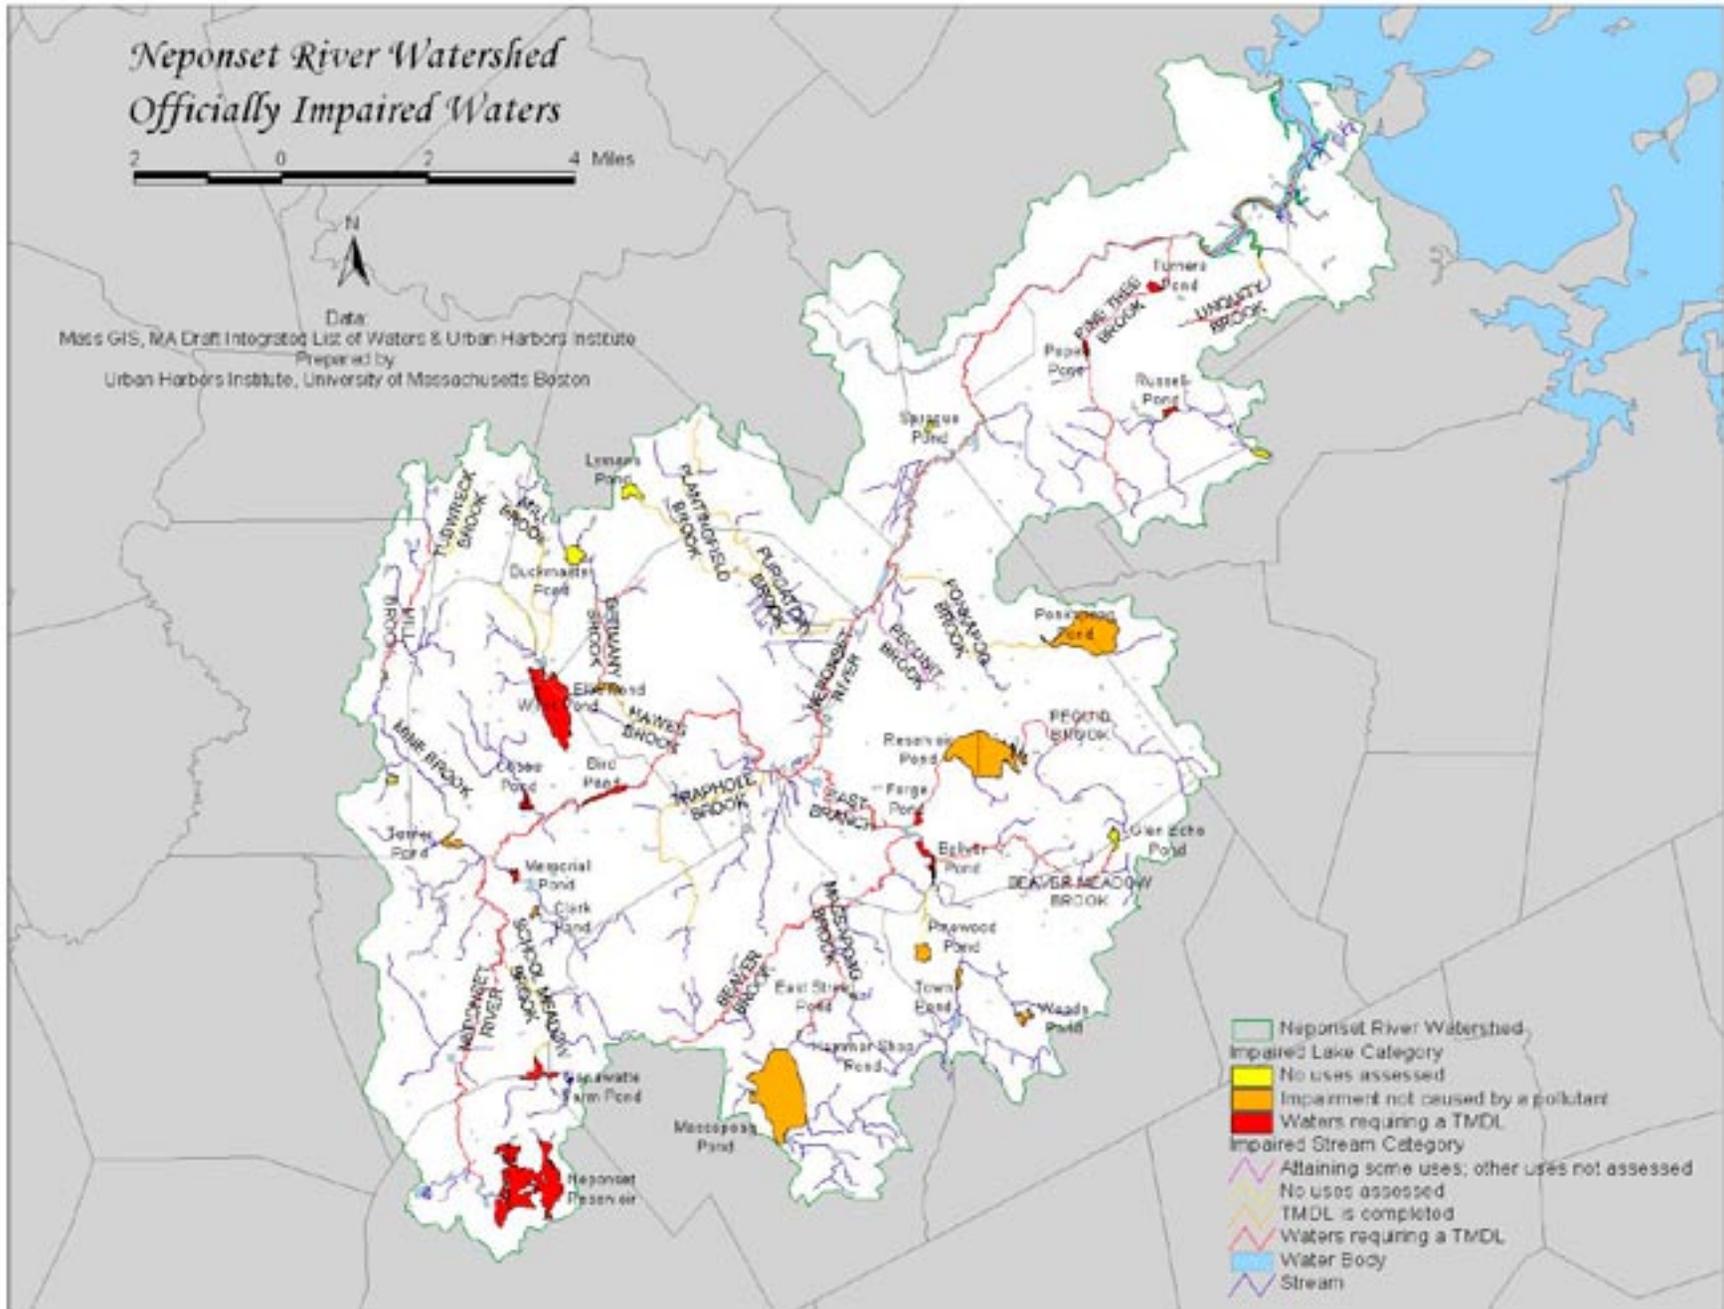
Figure 29: Neponset Officially Impaired Waters

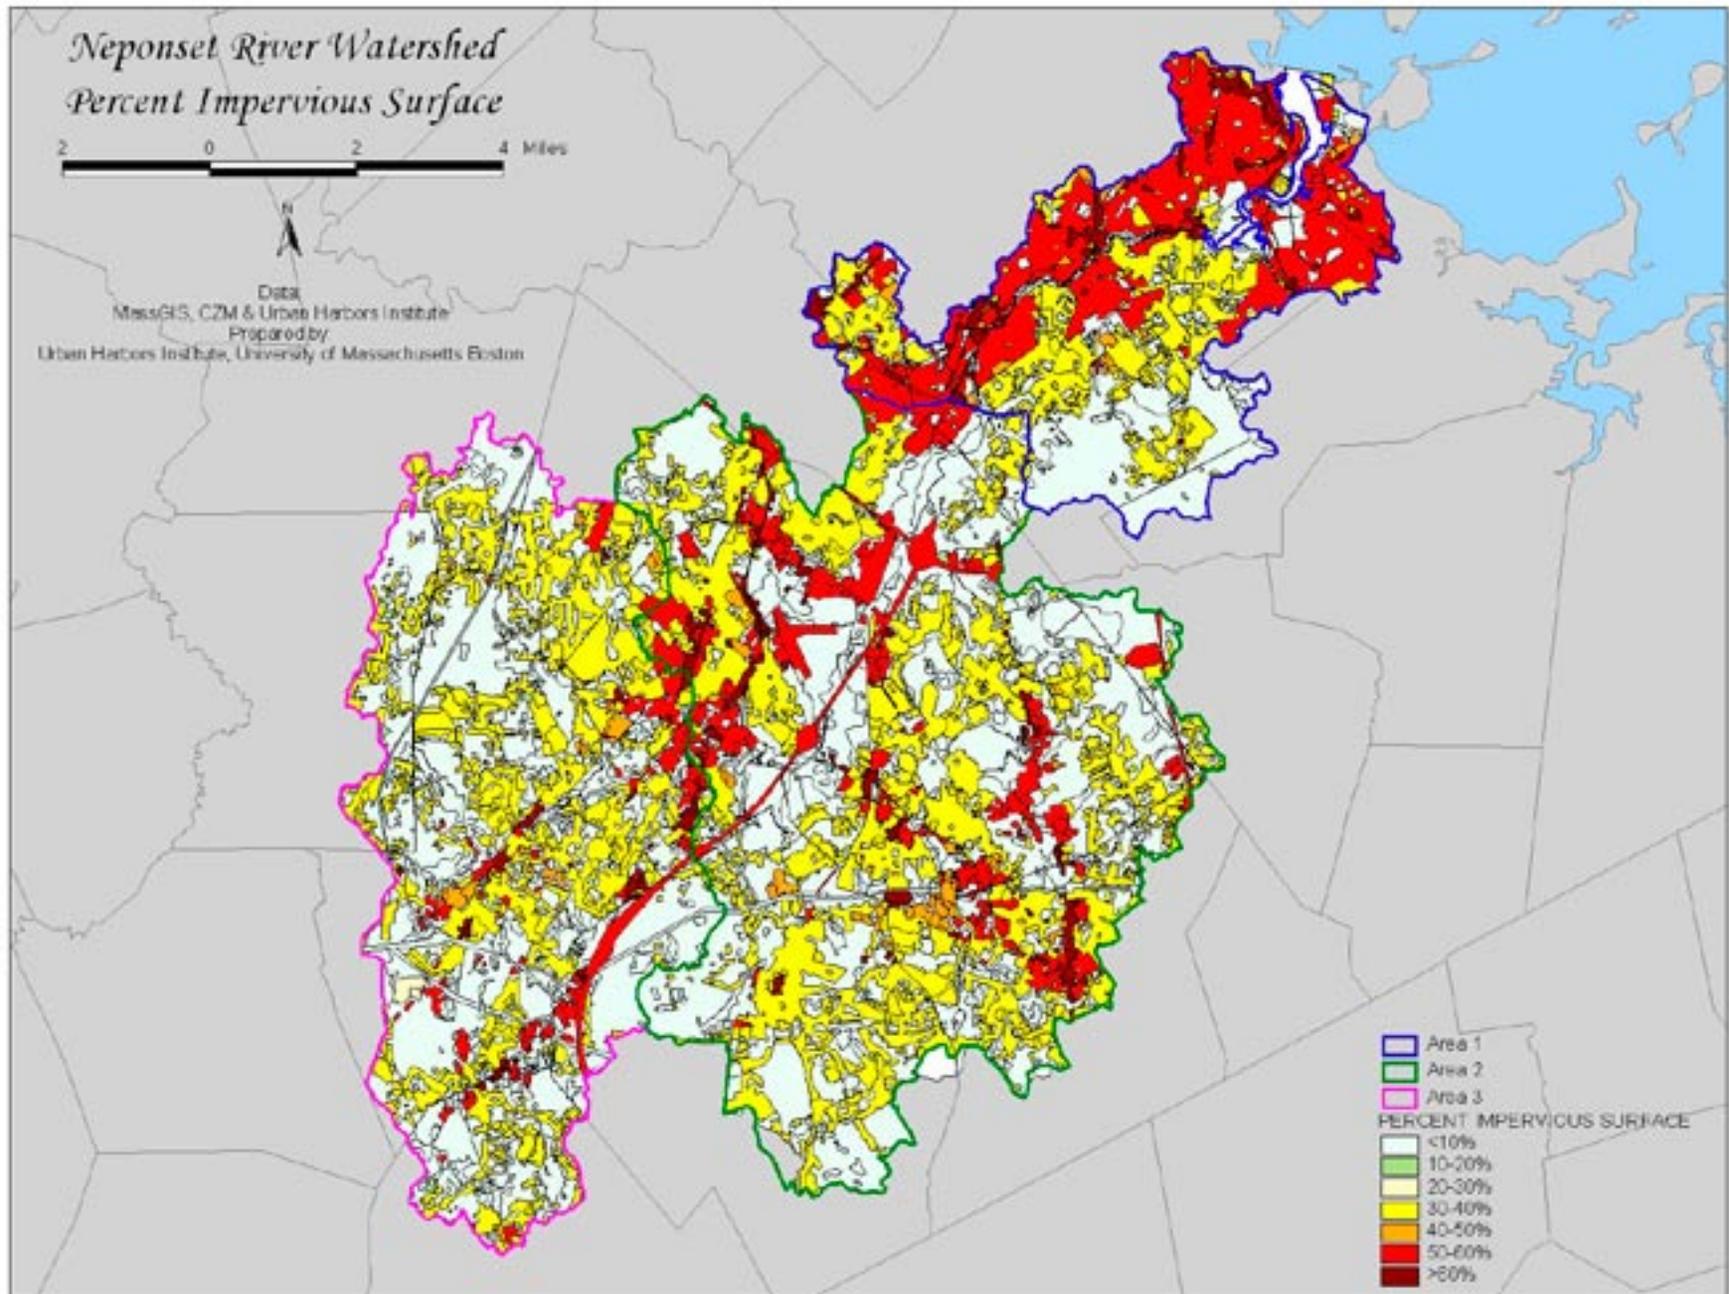
Figure 31: Neponset Imperviousness

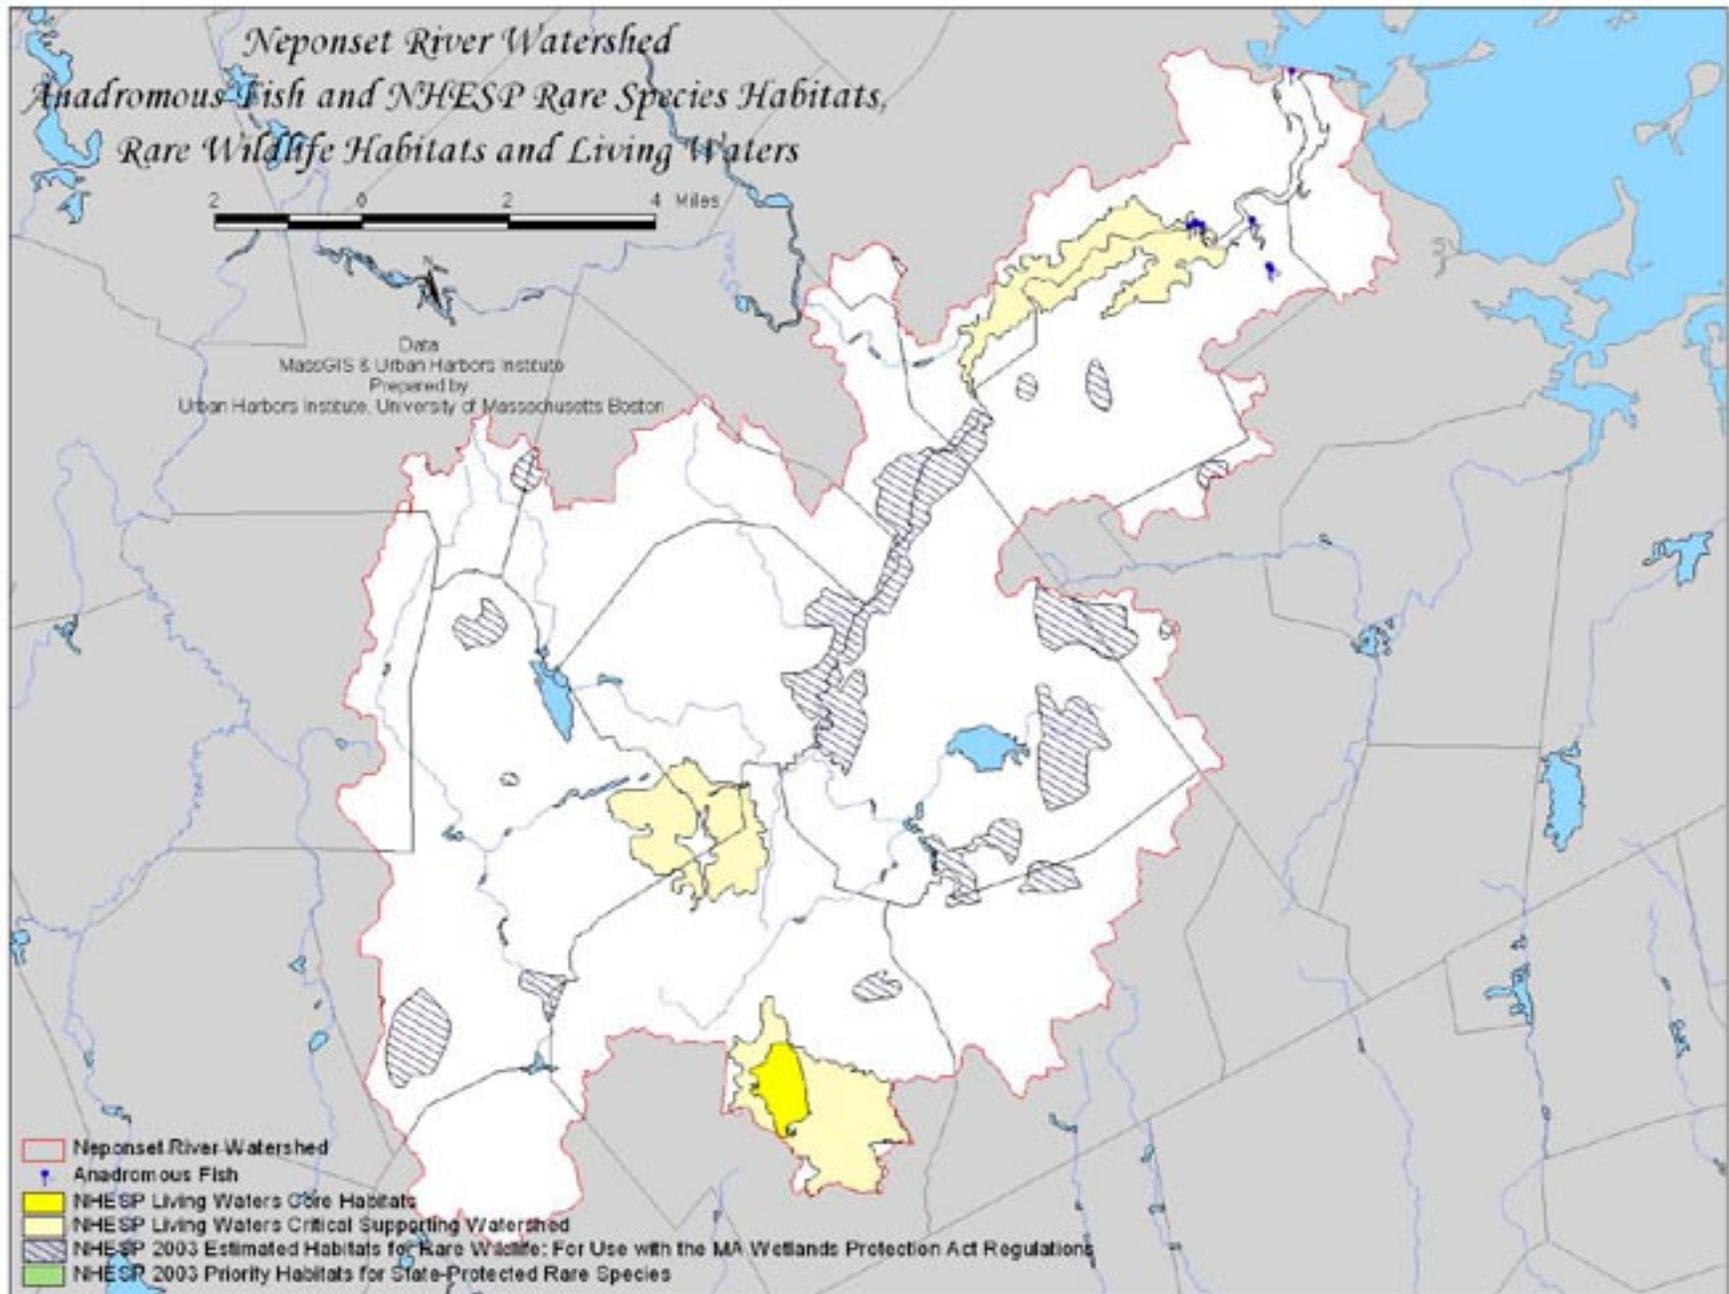
Figure 41: Neponset Anadromous Fish and Rare Species Habitats

Figure 41 includes Living Water Core Habitats, which identify

Massachusetts' most critical sites for freshwater biodiversity, where the state government believes we should focus proactive conservation activities. The MA Natural Heritage & Endangered Species Program based these sites on the presence of 58 species of rare fish, aquatic vascular plants, freshwater mussels, crayfish, snails, and other aquatic invertebrates. Changes in water flow and degradation in water quality threaten these and other freshwater species. (See map below.)

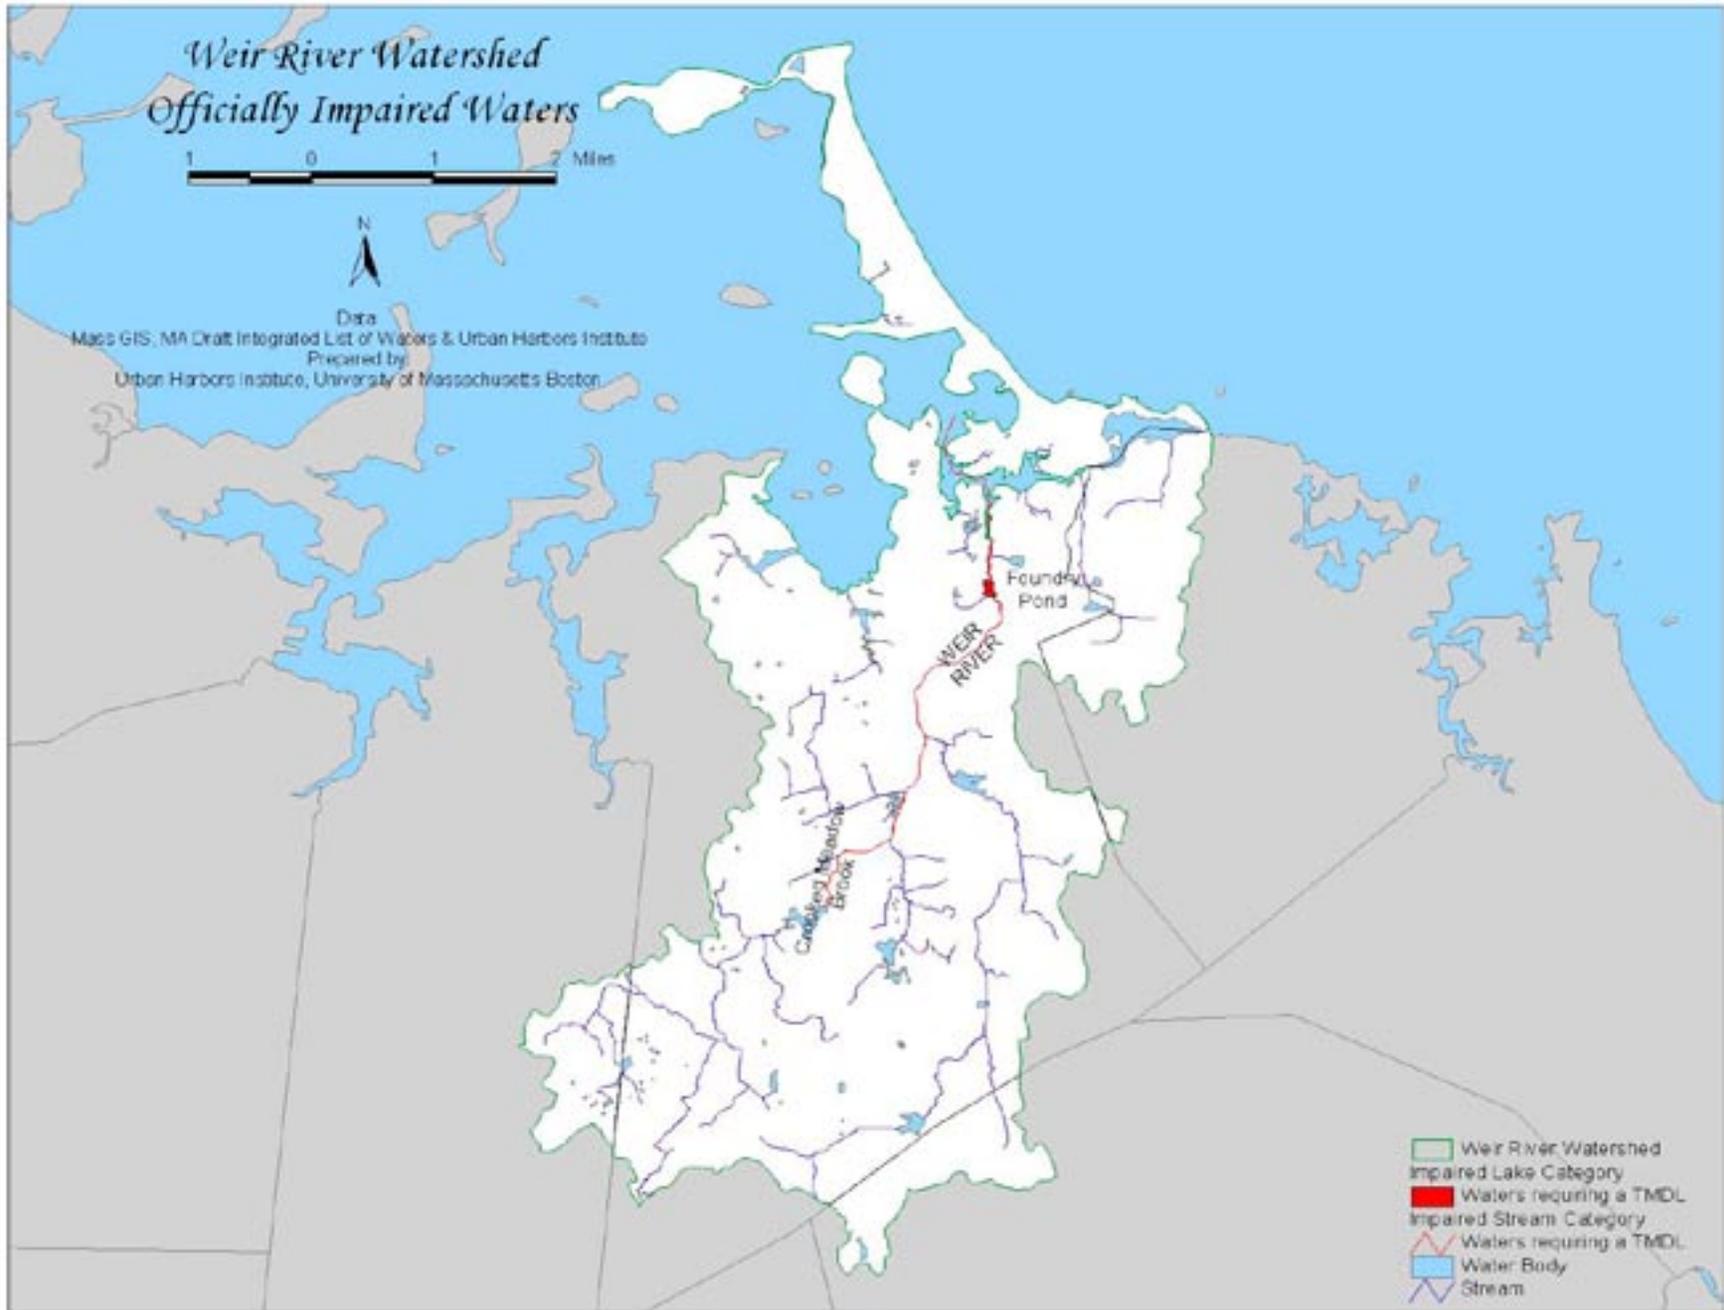
Figure 83: Weir Officially Impaired Waters (note majority of watershed is unassessed)
